Beauvoir Outbuildings & Landscapes

Handout for Tour

2012 Mississippi Historic Preservation Conference

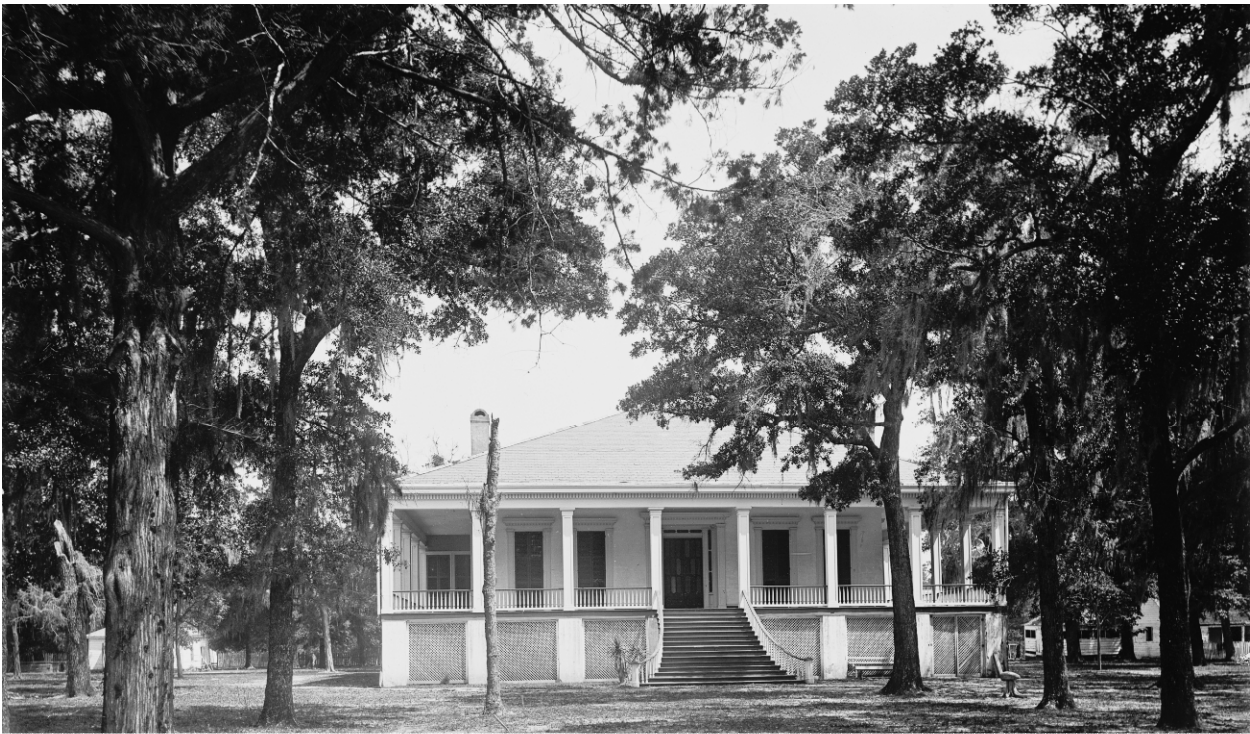
1901 image by the Detroit Publishing Company from the Library of Congress taken from just inside and west of the front gate looking north and slightly to the east.

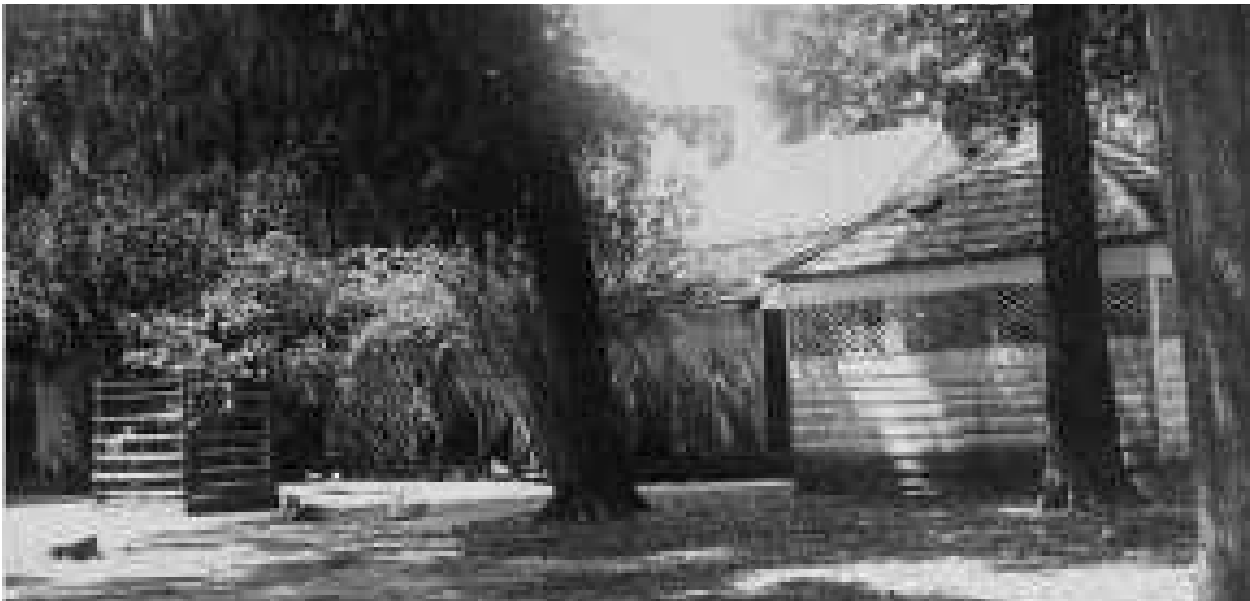
The Kitchen & the Connector to the Dining Wing of the House

An 1884 stereopticon image from the Library of Congress entitled "Under the Oaks" shows the food service area of the house. The rear wall of the dining wing is just out of sight to the left end of the lattice connector between the house and the kitchen, which is in the center of the picture (see enlarged detail below). Like the connector, the kitchen porch is faced with lattice. Lattice also encloses

the open windows wrapping around the upper wall of the chicken house to the far right. Such ventilation is typical of 18th and 19th-century chicken houses, from Williamsburg to Natchez and Biloxi. The detail below reveals that lumps on the ground are actually chickens and ducks, waddled down into the cool earth in the summer heat.

An 1873 *Notice for Sale* of the Brown estate (as Beauvoir was known then) is the first documented reference to a kitchen. It describes "a very convenient, comfortable and well built Kitchen and Large Store Room joining it, covered gallery to dining room built for enclosing in bad, cold or rainy weather, and communicating with the Wood Shed." This description matches the photographic evidence seen above. Unmentioned is the "dry well" that served as a refrigerator and still remains just inside the basement of the house, located between the end of the connector and the foot of the stairs to the dining room. The enclosed connector allowed servants to be unseen as they went about their duties, as was ideal in 19th century households in both Europe and America.

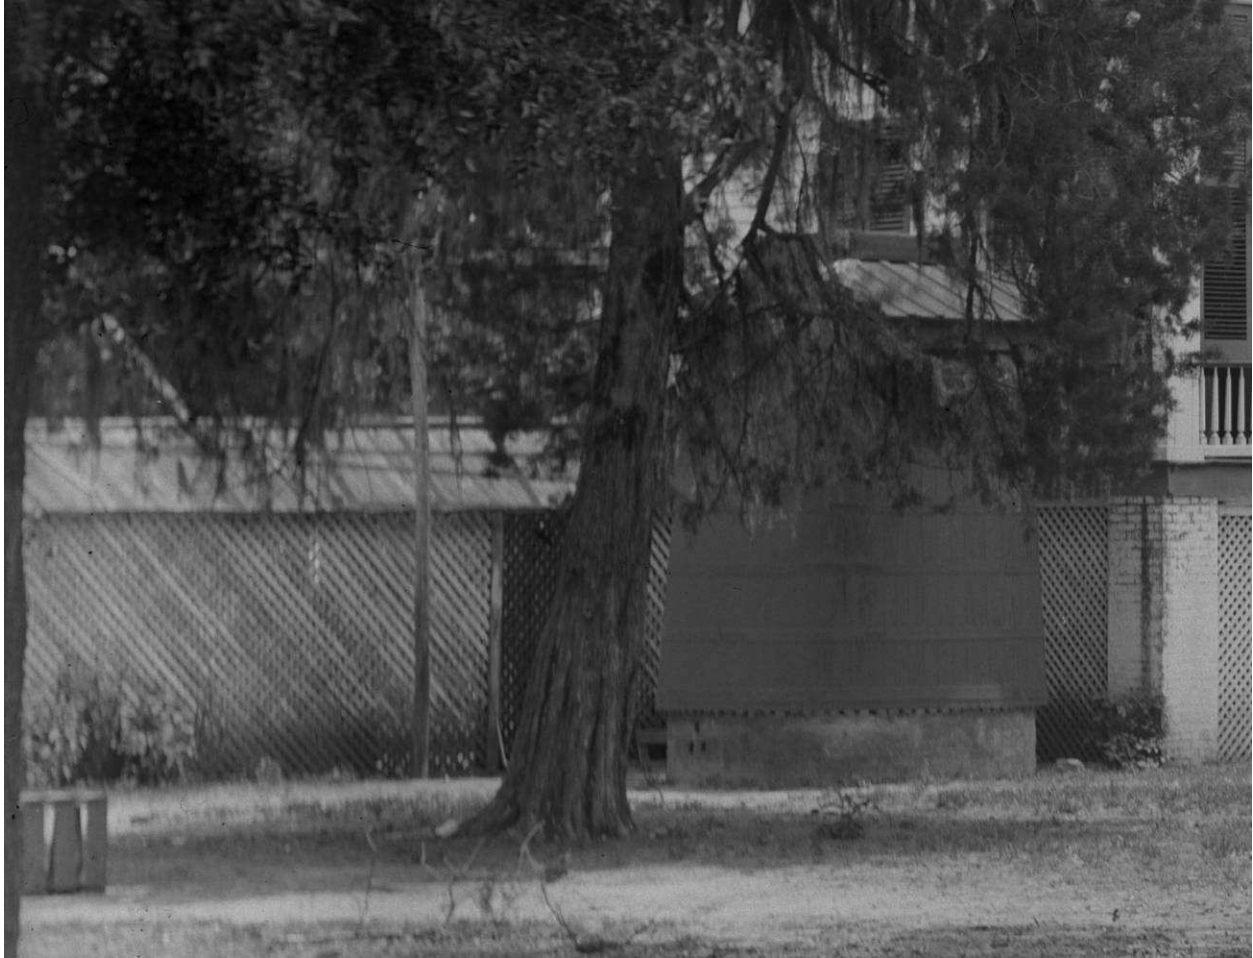
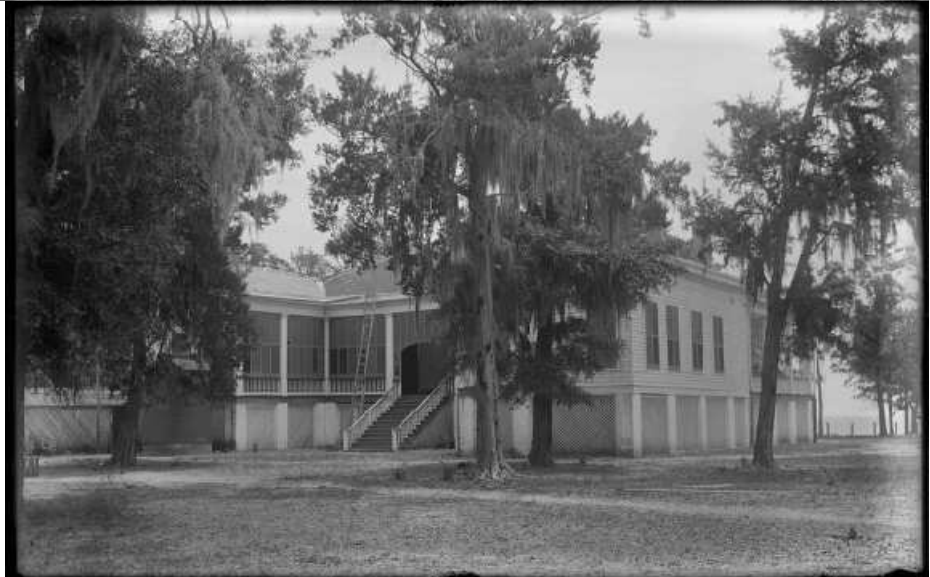
The Kitchen & the Connector to the Dining Wing of the House (looking southeast)

The detail above, taken from a 1901 image from the Paul Jermyn collection at right, shows the lattice connector (or gallery) between the house and the kitchen, as seen from the west side. You can see that the roof of the conductor was covered by boards and battens by 1901 (as was the roof of the gallery on the kitchen itself). The large tapered cylinder to the right of the connector is the above-ground cistern, which was filled by water conducted by pipes from the roof gutters.

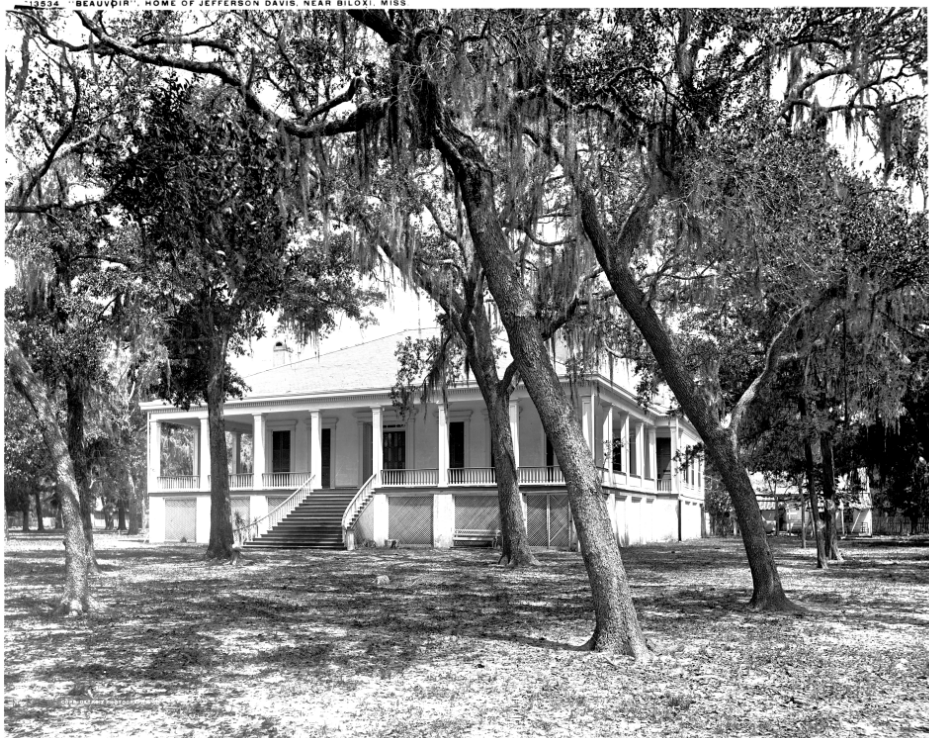
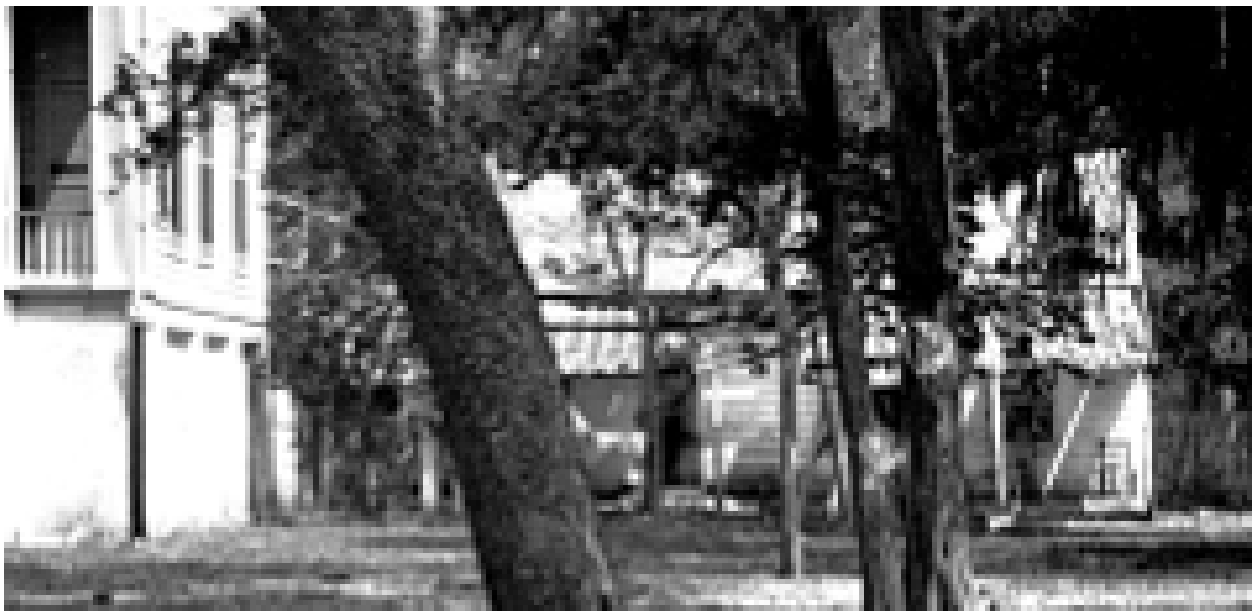
The Kitchen

The 1901 image by the Detroit Publishing Company on file at the Library of Congress was taken just inside and to the east of the front gate, looking at the front and east side of the house. If you stand in the same spot, you may be amazed that many of the same trees still stand after more than 100 years. At the back of the house, and just to the right, is the kitchen. As you

can see in the detail below, it was dilapidated only 12 years after Jefferson Davis's death. By this time, the lattice had been removed and the shingled porch roof seen in the 1884 photographs had been replaced by a board and batten roof which was falling apart, and had separated from the front eave of the roof of the kitchen. The attachment of the porch roof at the bottom edge of the main roof is unusual and is one reason that the porch is considered by some to be an addition to the original kitchen.

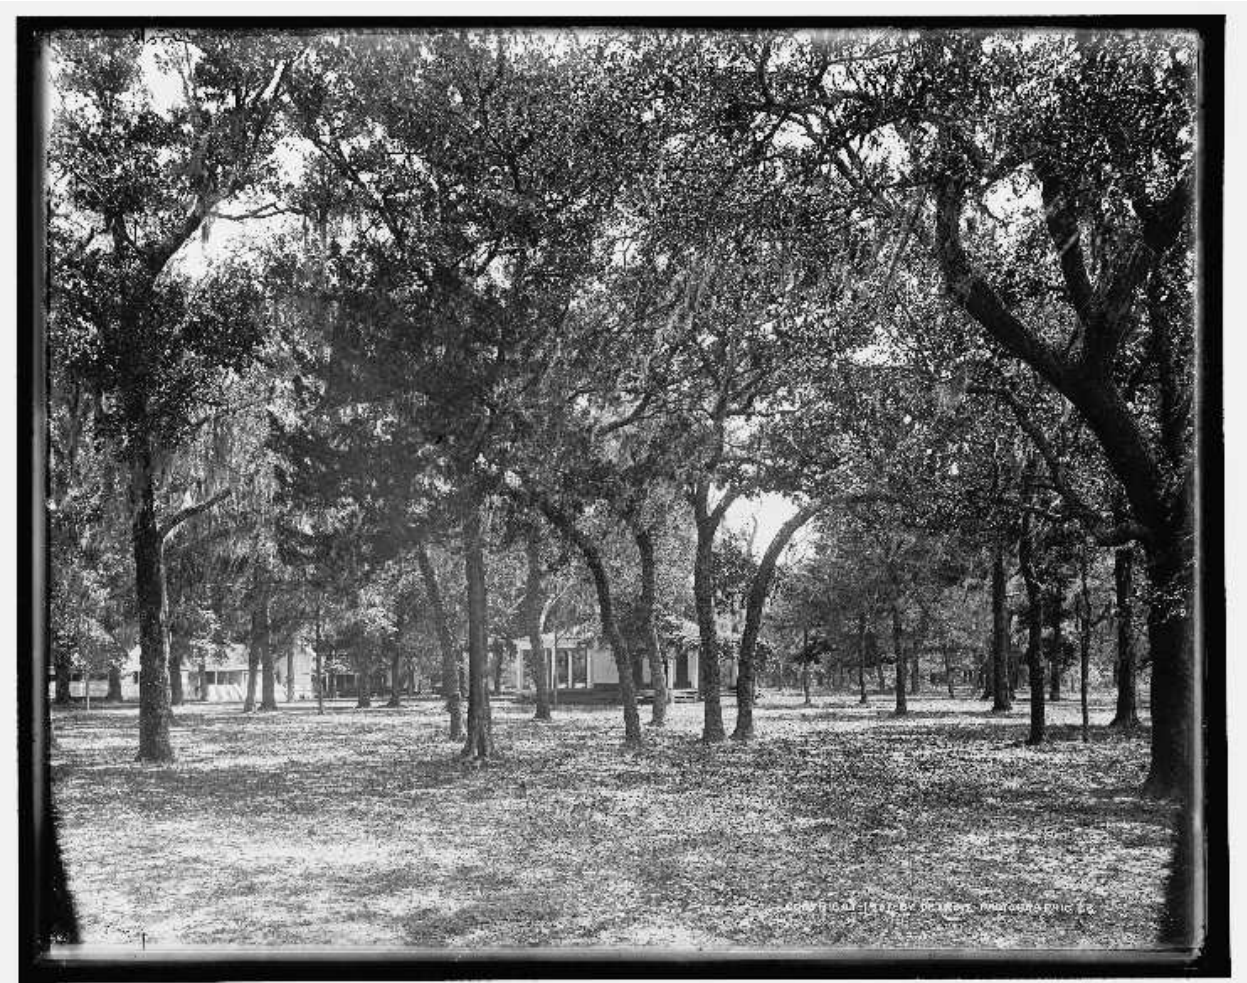
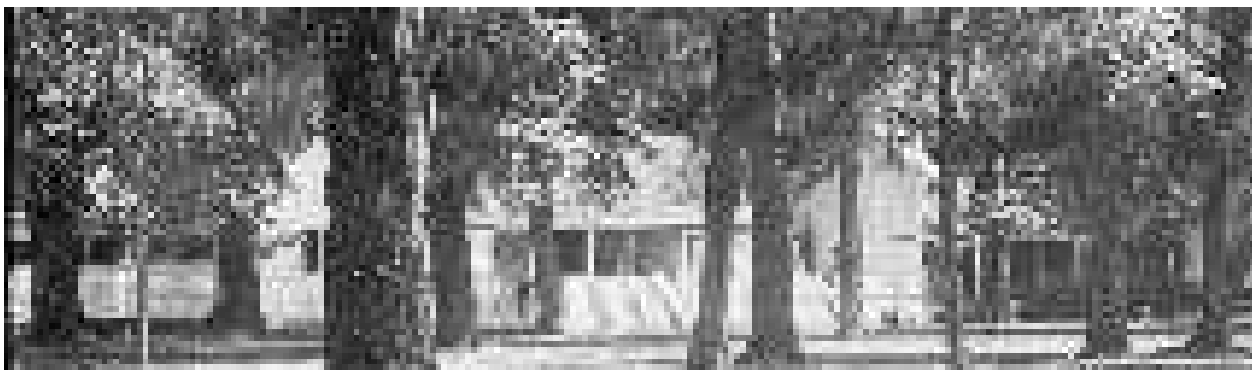
The Carpenters and Servants Houses

The 1901 image from the Library of Congress is taken from just inside the front gate looking east and slightly to the north. In the center is the library. To the left are three buildings, seen in more detail below. The left most, with the dark band of lattice around the top of the wall, is the chicken house, seen in an 1884 photograph called "Under the Oaks." To the right is, first, the Carpenters House, and to its right, the Servants House. On the next pages are details taken from this photograph. The details provided the information needed for the reconstruction of these two buildings .

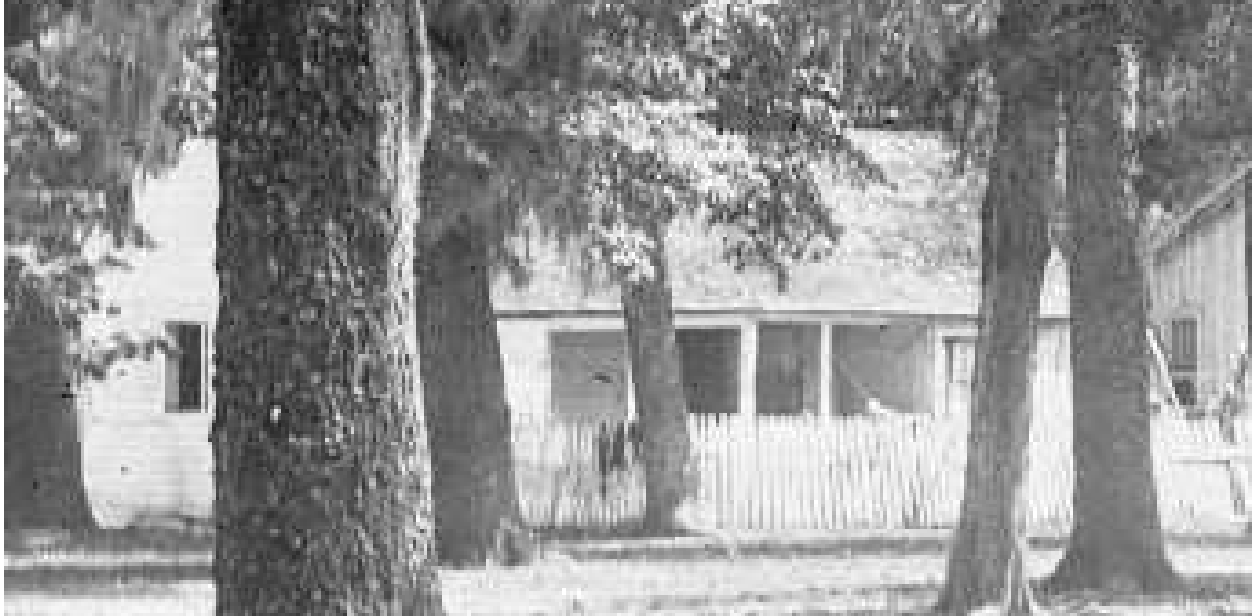
The **Carpenters House** shows some evidence of changes made over time. The board and batten cladding of the corner room at the east end of the porch is evidence that this porch room, called a “cabinet”, was added to the building, which is itself clad in clapboards, seen clearly on the end wall at the left. You can also see that the cabinet room at the west end is covered with clapboards, unlike the east cabinet room.

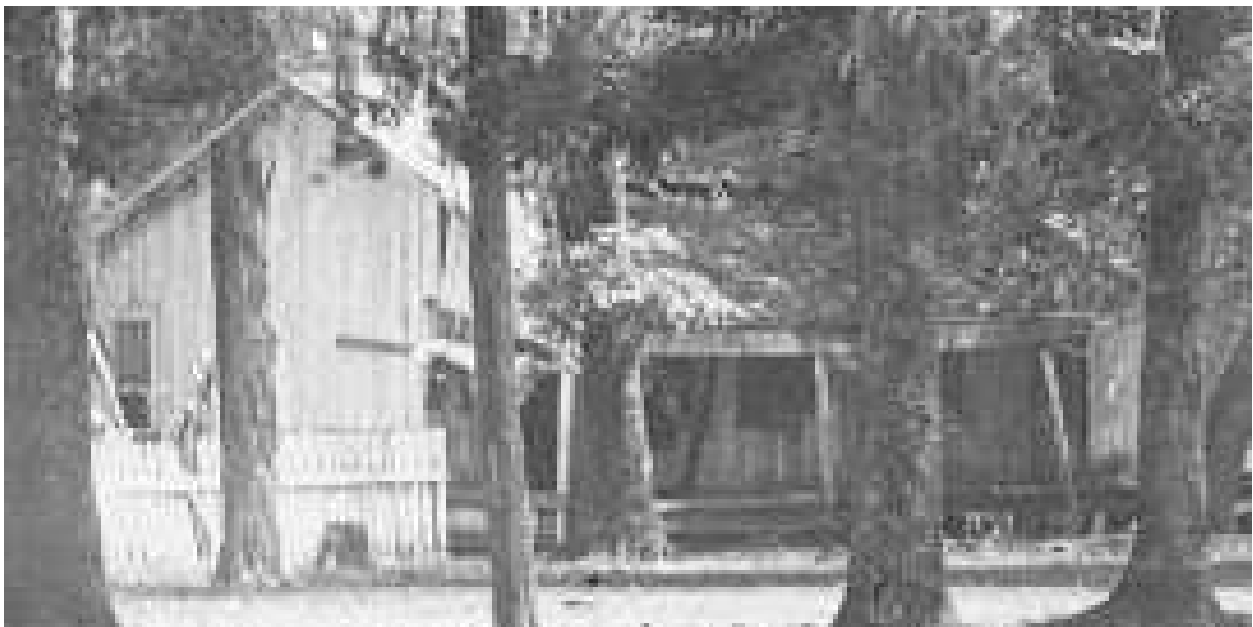
By 1901, many of the outbuildings had fallen into decline, as seen in this image of the **Servants House**, where the posts of the front gallery have fallen and are resting on the ground, causing the porch roof to separate from the main roof of the building. Note the board and batten siding on the entire building as well as the cabinet room at right.
